Independently certified audit of the long term on-site performance of continuously anodised aluminium panels on exterior architectural applications in Continental Europe

PURE ALUMINIUM

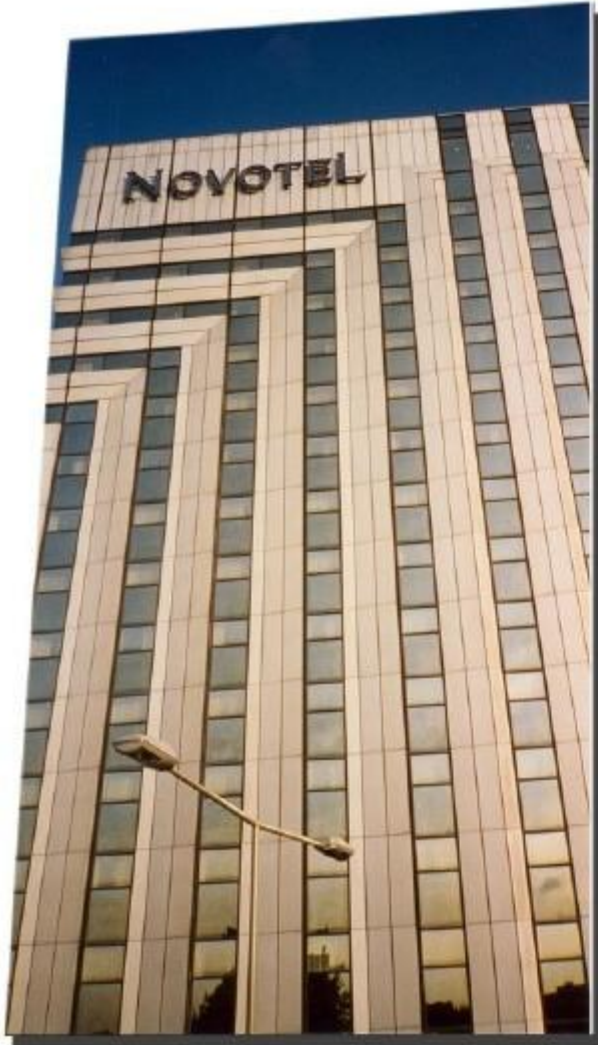
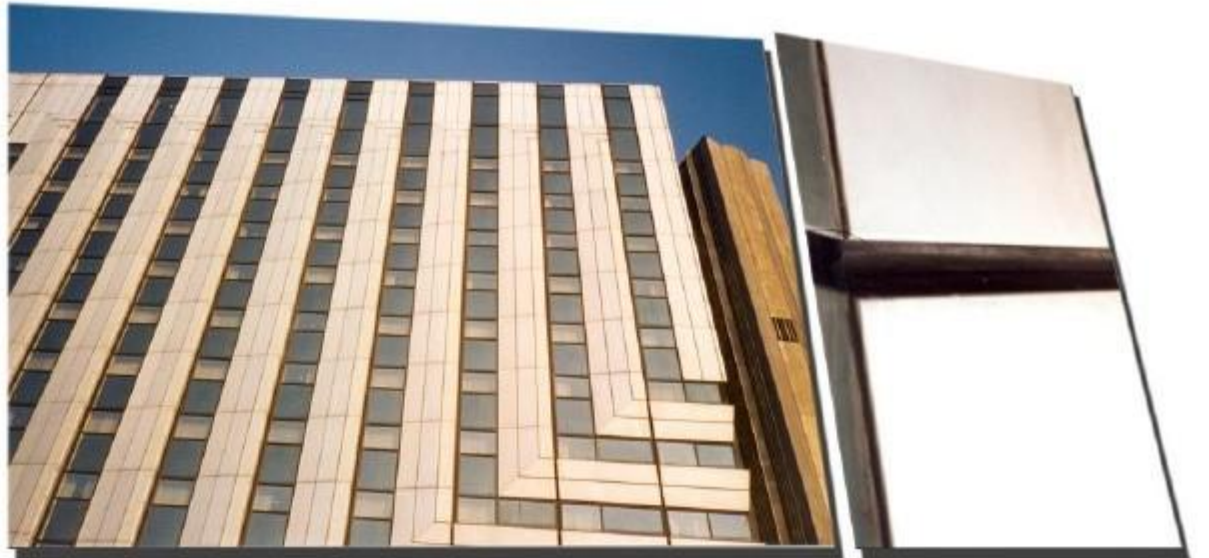
Address of building	COMPLEXE D'HOTEL NOVOTEL-IBIS 4,Boulevard de Neuilly 92081 PARIS-LA-DEFENSE, FRANCE
Date of independent inspection	July 2003
Use of building	Hotel
Date of construction	1983
Environment	High traffic density–business district of La Défense–Paris
Evidence of regular cleaning or maintenance	Yes, twice annually
External parts of building which were anodised	Panels – Cassettes
Treatment	Continuous coil anodised
Anodiser	Coil N.V., Belgium
Colour	Clear
Original anodic film layer on anodised parts (microns)	Class 15µm (EN12373-1)
Anodic film layer on date of independent inspection (microns)	16µm

Visible signs of corrosion or surface degradation	None
Conclusion	After 20 years, no apparent corrosion and no reduction in anodic film despite high density urban environment

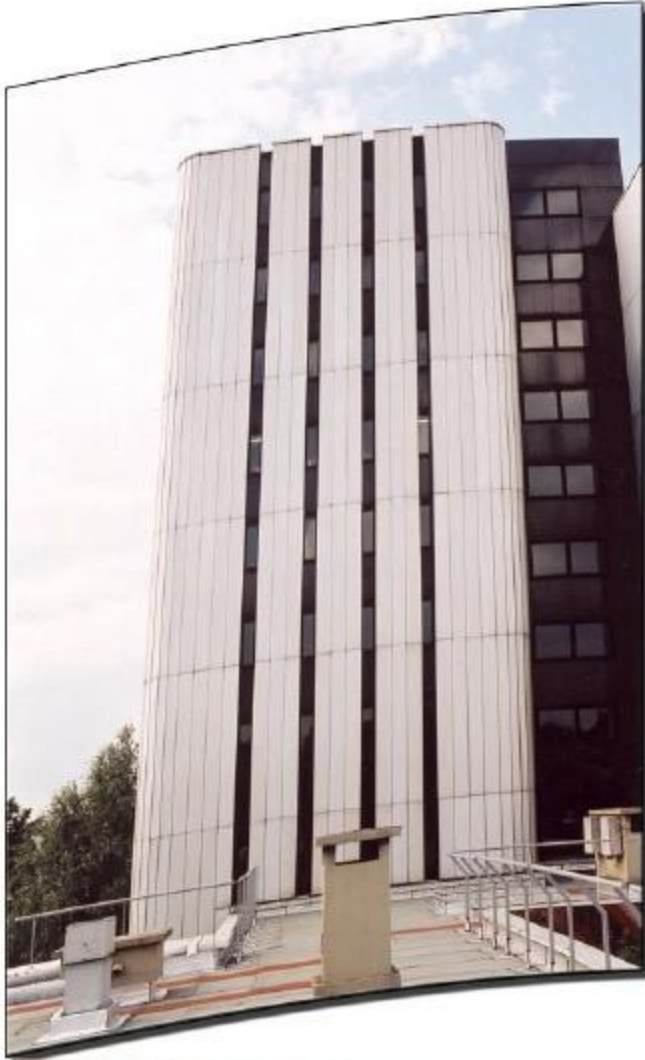
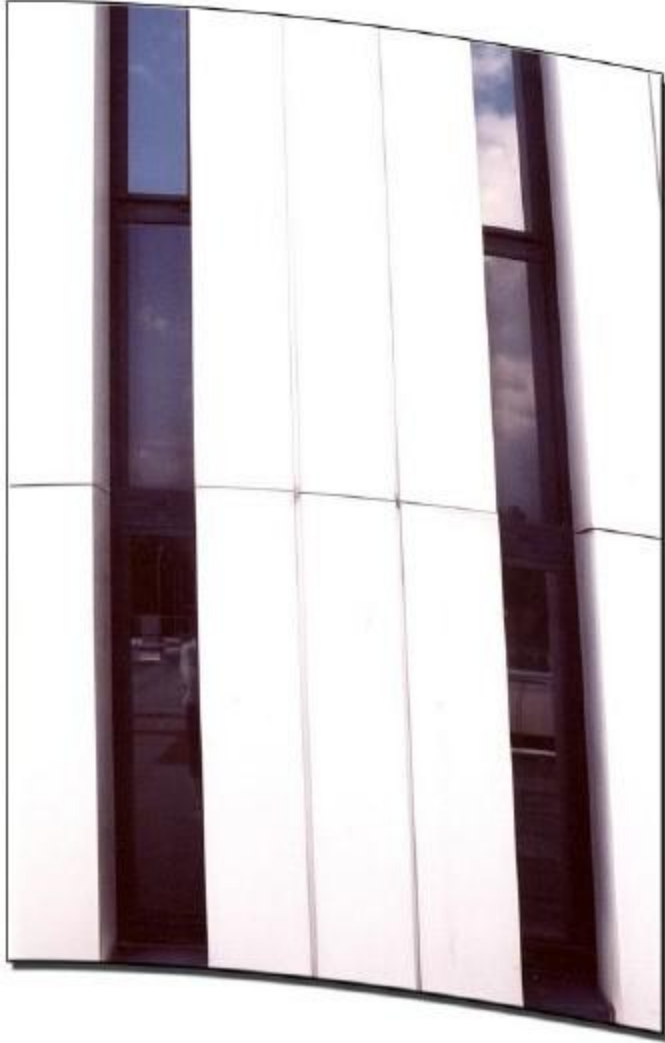
Address of building	LES ARCHIVES DEPARTEMENTALES DES HAUTS DE SEINE 137, avenue Joliot Curie, 92023 NANTERRE-FRANCE
Date of independent inspection	July 2002
Use of building	Public building
Date of construction	1978
Environment	Urban – High traffic density
Evidence of regular cleaning or maintenance	No
External parts of building which were anodised	Panels – Vertical cassettes 3.4mx0.33m
Treatment	Continuous coil anodised
Anodiser	Coil N.V., Belgium
Colour	Clear
Original anodic film layer on anodised parts (microns)	Class 15µm (EN12373-1)

Anodic film layer on date of independent inspection (microns)	18 μ m
Visible signs of corrosion or surface degradation	None
Conclusion	After 24 years, no apparent signs of corrosion and no reduction in anodic film despite high density urban environment.

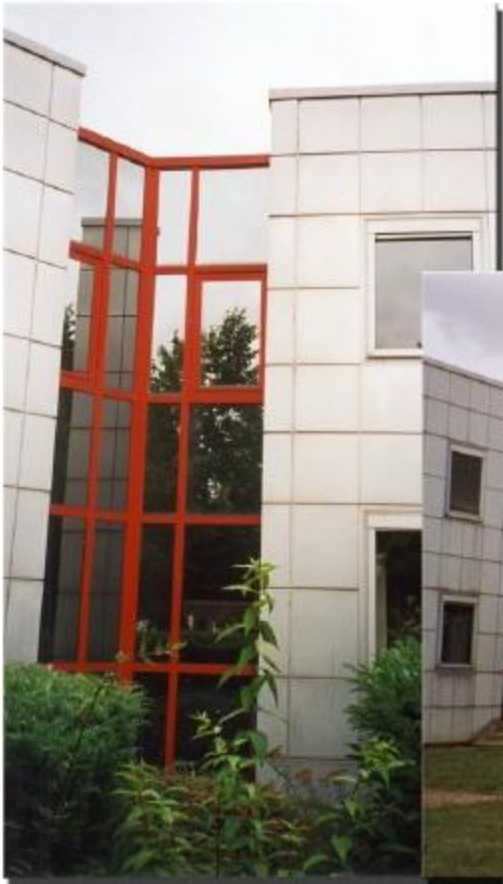
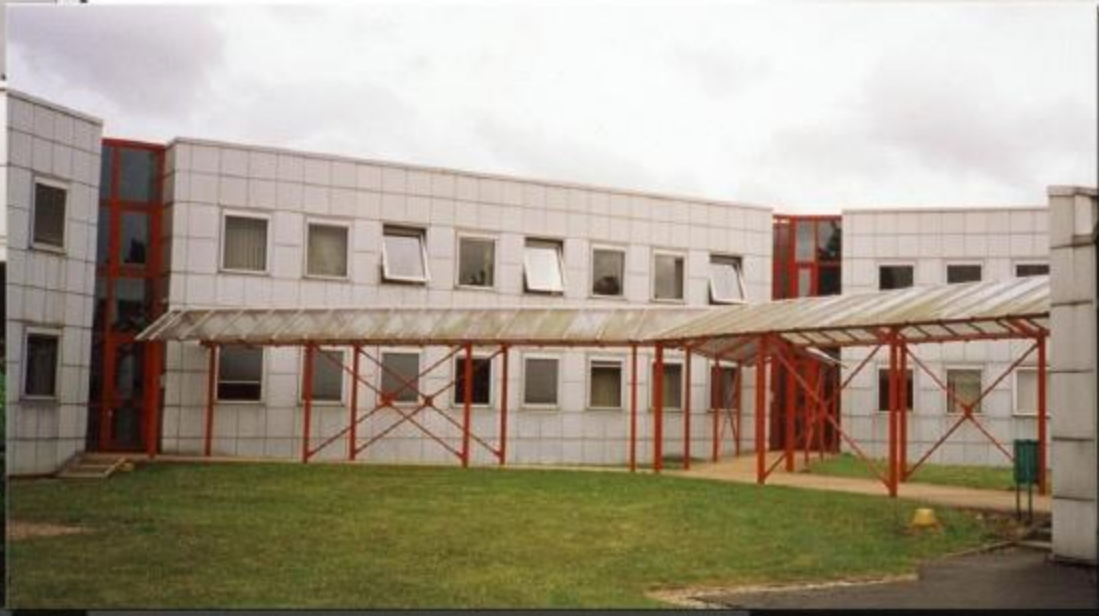
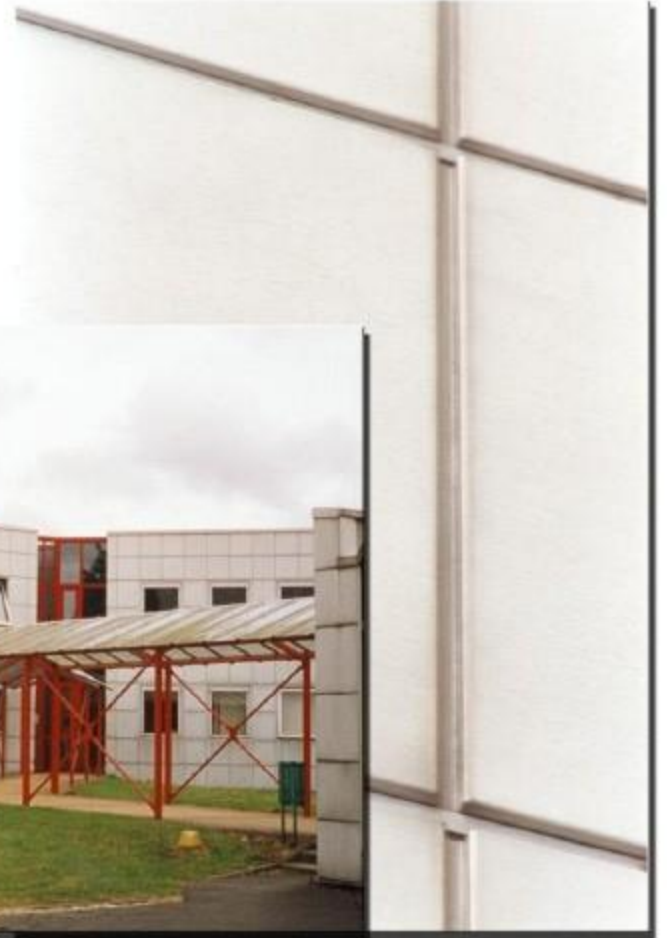
Address of building	CENTRE EDF-GDF 4, avenue du Pacifique, ZA Courtaboeuf, 91940 LES ULIS FRANCE
Date of independent inspection	July 2002
Use of building	Offices
Date of construction	1982
Environment	Semi rural – semi industrial close to Orly Airport–subject to pollution due to kerosene vapours from over-flying
Evidence of regular cleaning or maintenance	None during the last 20years
External parts of building which were anodised	Panels – Cassettes-1.3mx0.6m
Treatment	Continuous coil anodised
Anodiser	Coil N.V., Belgium
Colour	Clear
Original anodic film layer on anodised parts (microns)	Class 15µm (EN12373-1)
Anodic film layer on date of independent inspection (microns)	16µm

None

After 20 years, no apparent signs of corrosion and no reduction in anodic film.

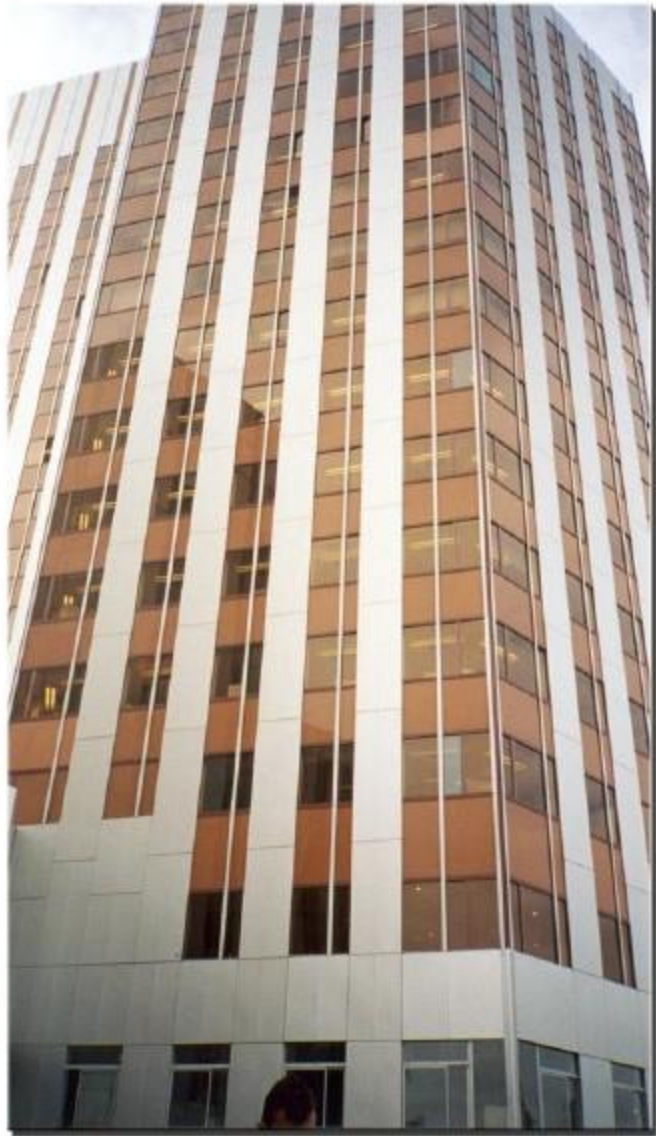
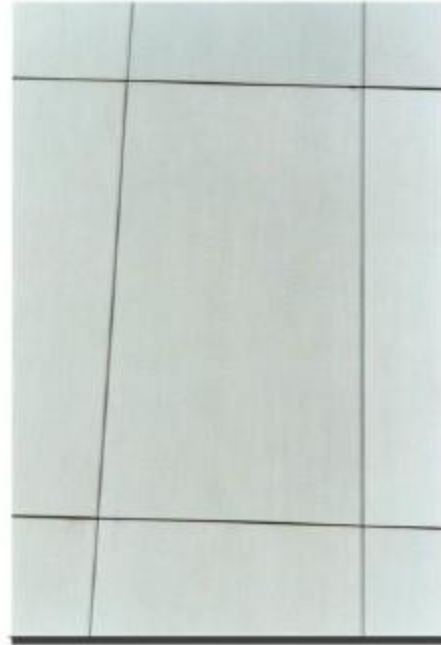
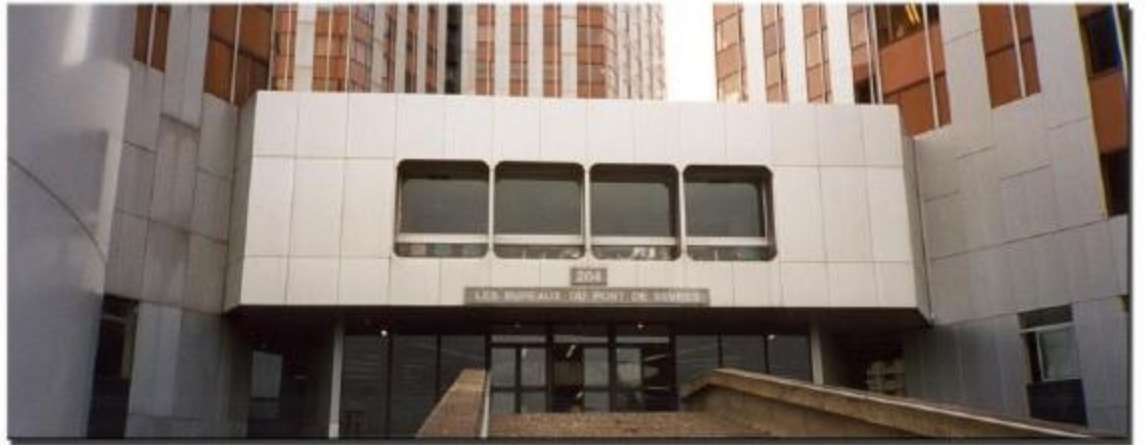
Address of building	LES BUREAUX DU PONT DE SEVRES 204, Pont de Sèvres 92510 BILLANCOURT-FRANCE
Date of independent inspection	July 2002
Use of building	Offices
Date of construction	1975
Environment	Urban – by Seine river–High traffic density
Evidence of regular cleaning or maintenance	None since construction
External parts of building which were anodised	Panels – Cassettes -2.7mx0.6m
Treatment	Continuous coil anodised
Anodiser	Coil N.V., Belgium
Colour	Clear
Original anodic film layer on anodised parts (microns)	Class 15µm (EN12373-1)
Anodic film layer on date of independent inspection (microns)	17µm

None

After 27 years, no apparent signs of corrosion and no reduction in anodic film despite high density urban environment.

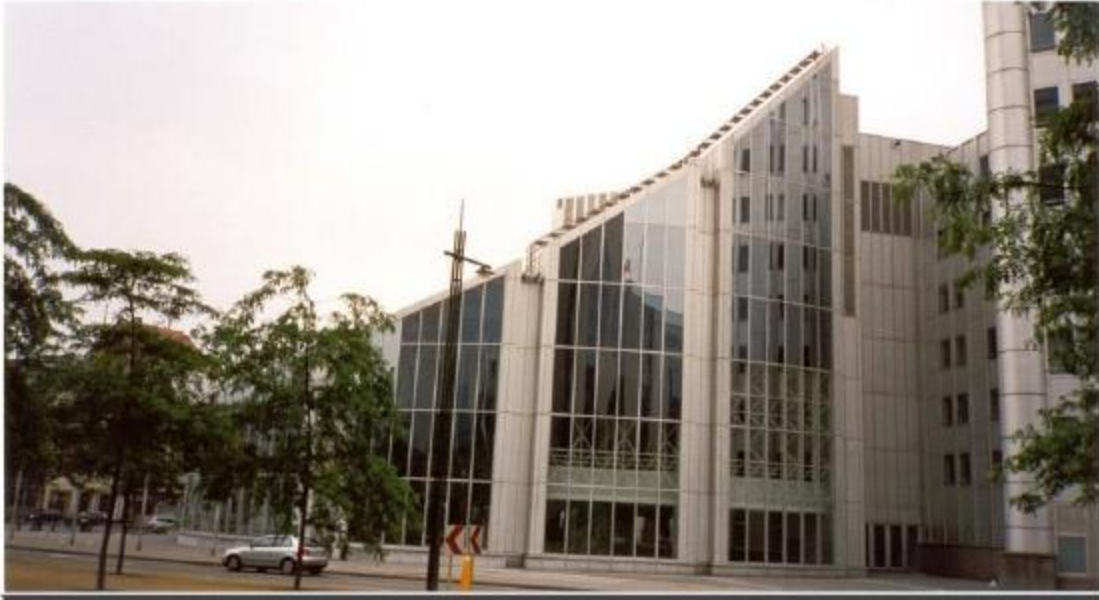
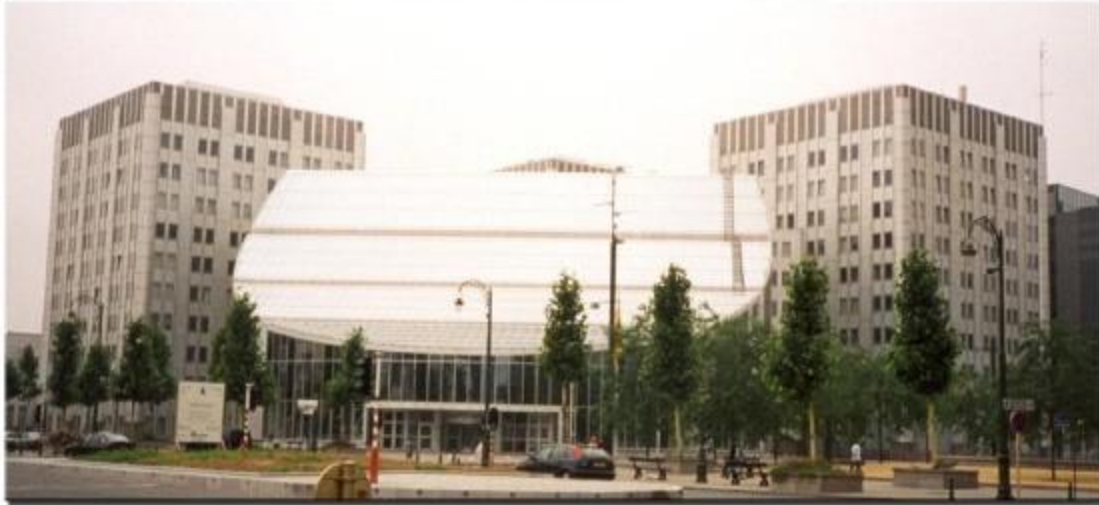
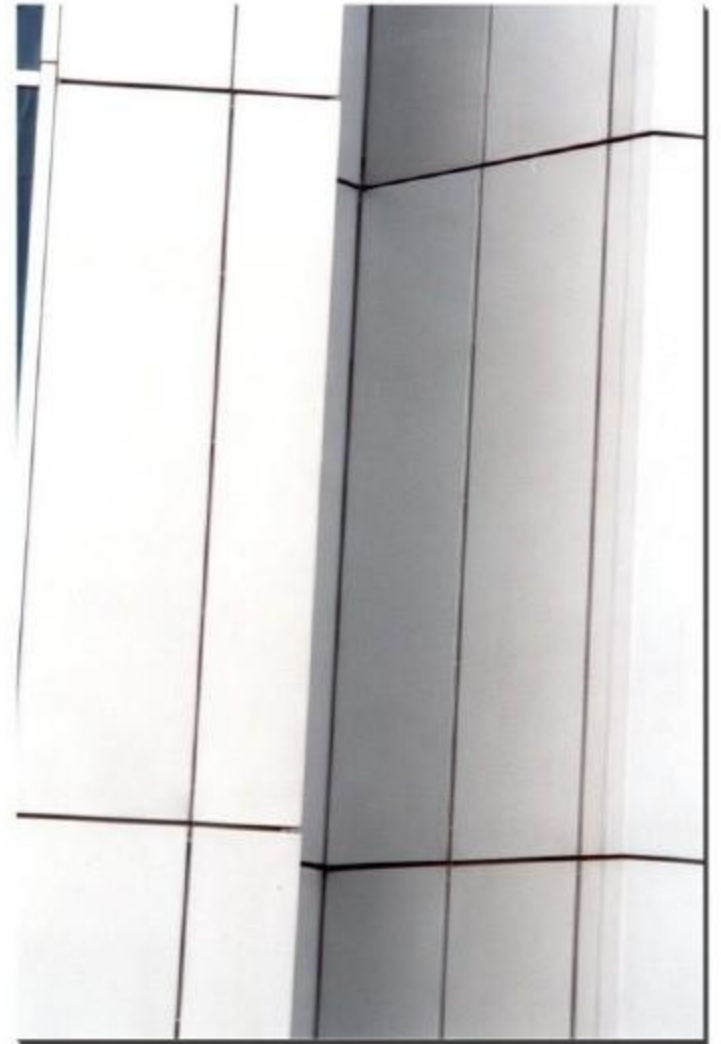
Address of building	MINISTERE DE LA COMMUNAUTE FLAMANDE - BATIMENT BAUDOUIN 30, avenue Albert II 1000 BRUXELLES-BELGIUM
Date of independent inspection	August 2002
Use of building	Government building
Date of construction	1989
Environment	Urban – City centre – High traffic density
Evidence of regular cleaning or maintenance	Yes, first time after 5 years service life, annually thereafter
External parts of building which were anodised	Panels – Cassettes
Treatment	Continuous coil anodised
Anodiser	Coil N.V., Belgium
Colour	Clear
Original anodic film layer on anodised parts (microns)	Class 15µm (EN12373-1)
Anodic film layer on date of independent inspection (microns)	18µm

Visible signs of corrosion or surface degradation	None
Conclusion	After 23 years, no apparent signs of corrosion and no reduction in anodic film despite high density urban environment.

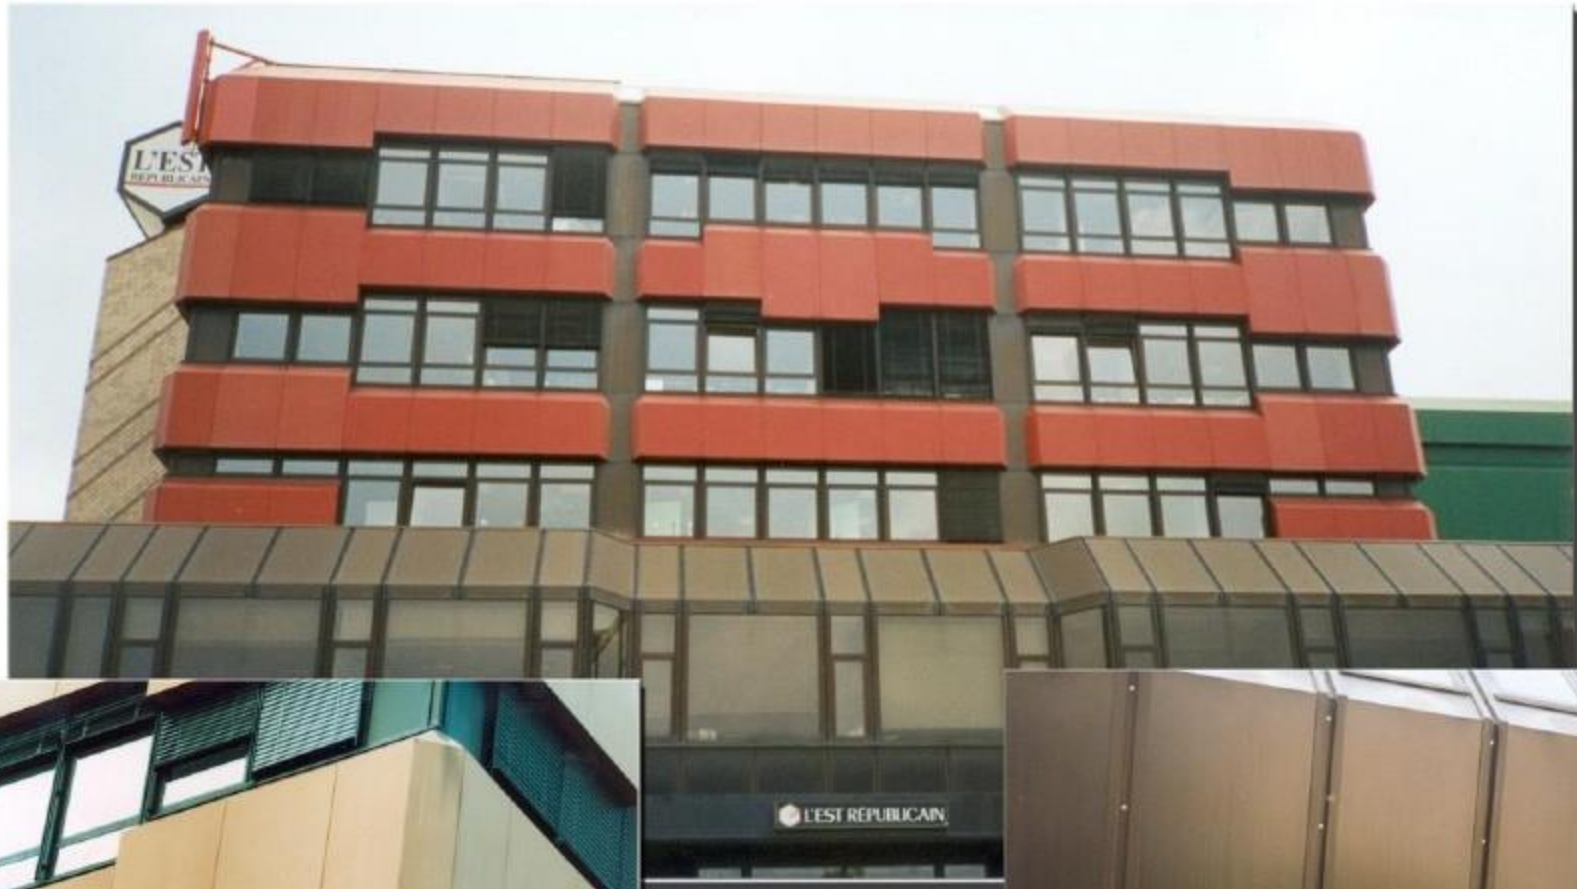
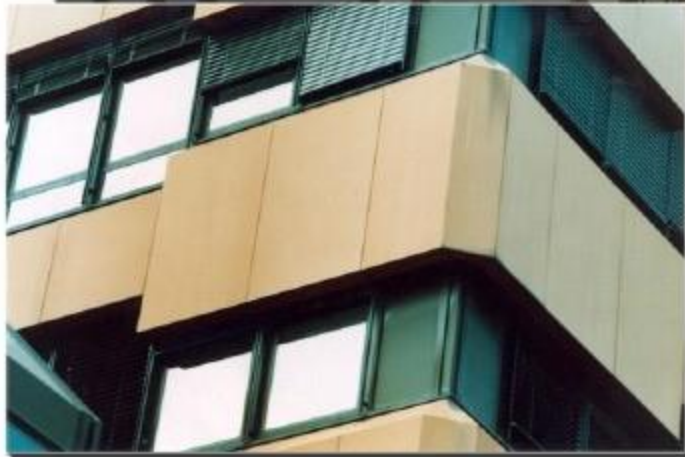
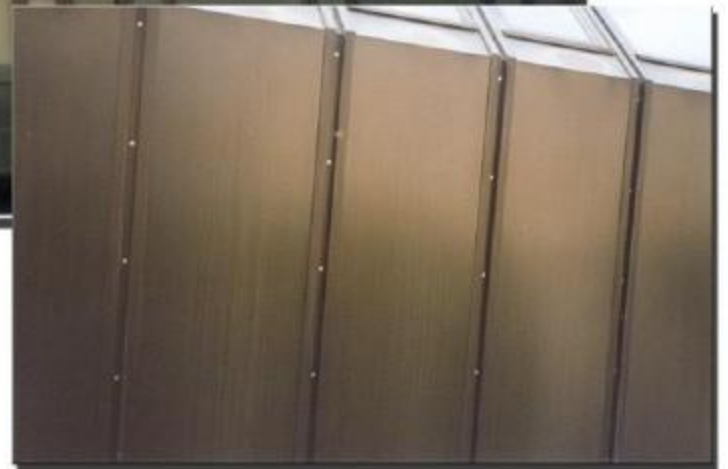
Address of building	L'EST REPUBLICAIN 54180 HOUEMONT (NANCY) - FRANCE
Date of independent inspection	August 2002
Use of building	Newspaper offices
Date of construction	1982
Environment	Rural zone in suburb of Nancy – proximity of a highway cross section
Evidence of regular cleaning or maintenance	None since construction
External parts of building which were anodised	Solid panels
Treatment	Continuous coil anodised
Anodiser	Coil N.V., Belgium
Colour	Bronze
Original anodic film layer on anodised parts (microns)	Class 15µm (EN12373-1)
Anodic film layer on date of independent inspection (microns)	17µm

Visible signs of corrosion or surface degradation	None
Conclusion	After 20 years, no apparent signs of corrosion and no reduction in anodic film.

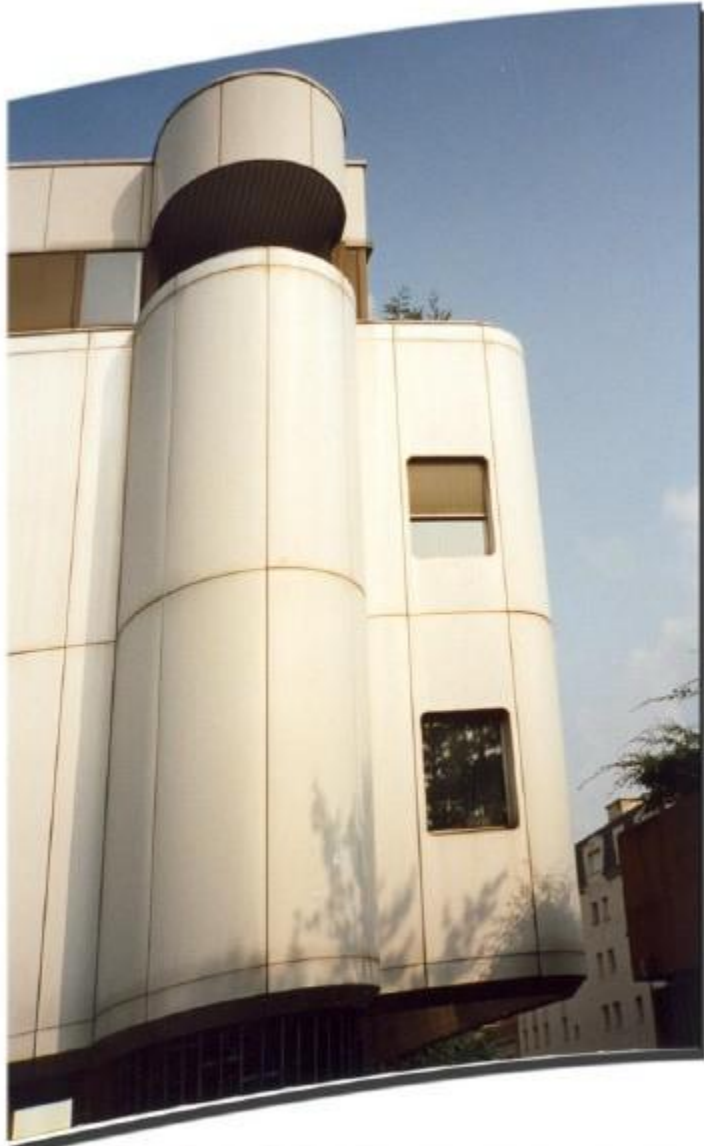
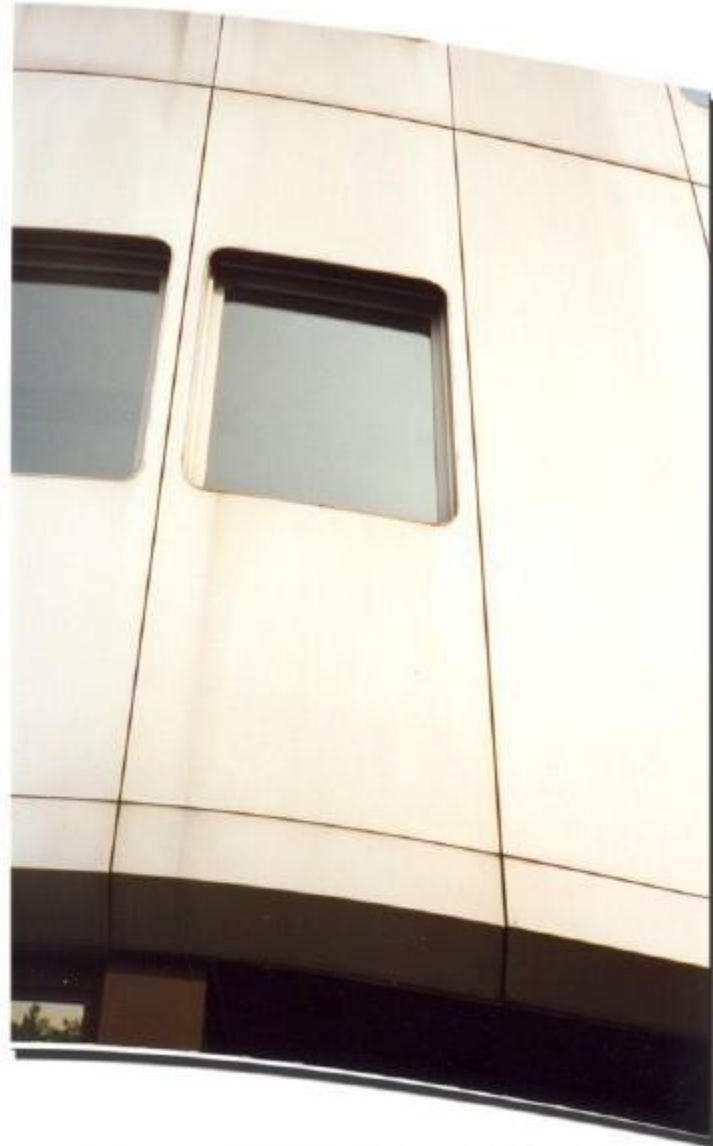
Address of building	PERNOD – RESIDENCE BERENICE 13, Boulevard Charles V 54000 NANCY-FRANCE
Date of independent inspection	August 2002
Use of building	Commercial offices
Date of construction	1981
Environment	Urban – suburb of Nancy
Evidence of regular cleaning or maintenance	None since construction
External parts of building which were anodised	Panels – Cassettes 3mx1m and 1mx1m
Treatment	Continuous coil anodised
Anodiser	Coil N.V., Belgium
Colour	Clear
Original anodic film layer on anodised parts (microns)	Class 15µm (EN12373-1)
Anodic film layer on date of independent inspection (microns)	16µm

Visible signs of corrosion or surface degradation	None
Conclusion	After 21 years, no apparent signs of corrosion and no reduction in anodic film.

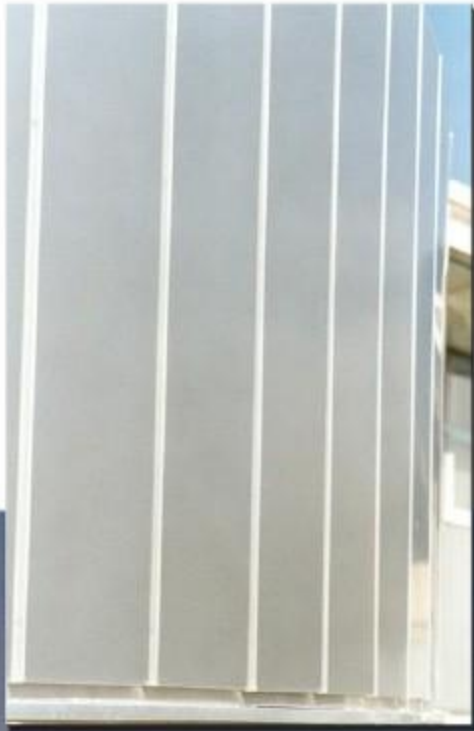
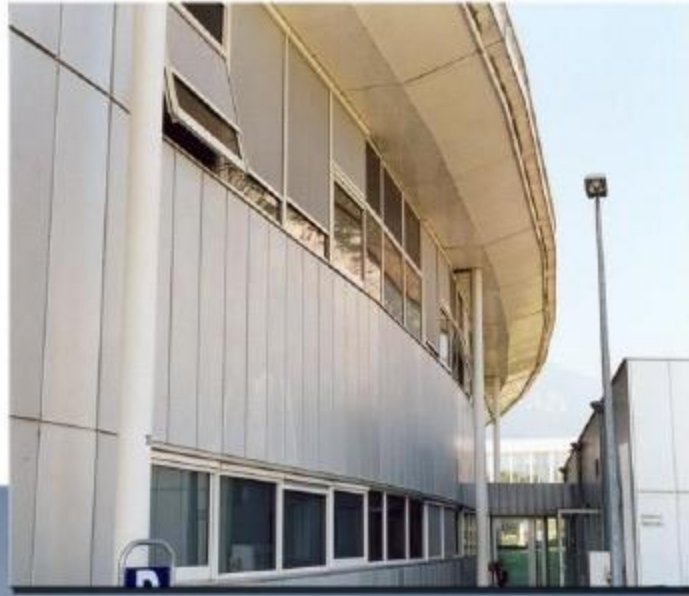
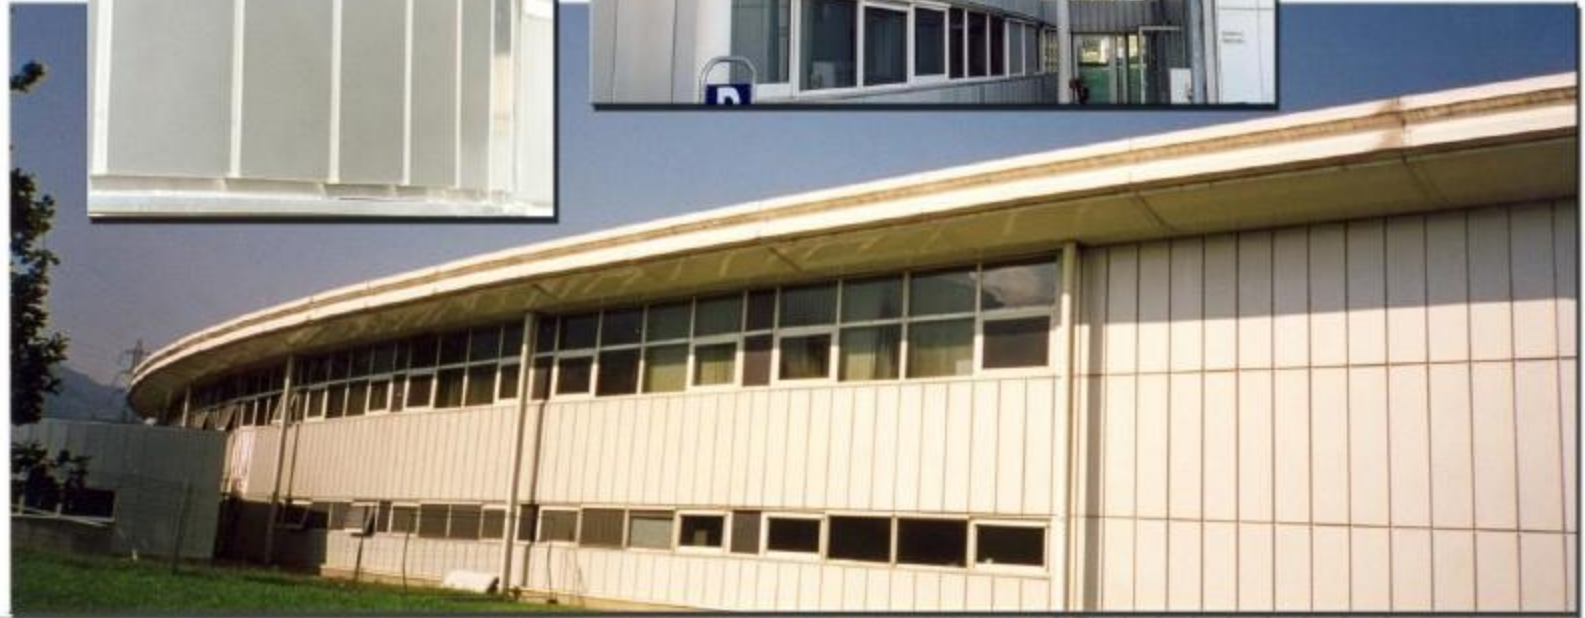
Address of building	EUROPEAN SYNCHROTRON RADIATION FACILITY 6, rue Jules Horowitz 38000 GRENOBLE-FRANCE
Date of independent inspection	September 2002
Use of building	Synchrotron – particles accelerator
Date of construction	1991
Environment	Centre of Grenoble valley – highly polluted area with high traffic density – close to intersection of two rivers
Evidence of regular cleaning or maintenance	No
External parts of building which were anodised	Panels – Cassettes – 0.6mx2m and 0.6mx0.65m
Treatment	Continuous coil anodised
Anodiser	Coil N.V., Belgium
Colour	Clear
Original anodic film layer on anodised parts (microns)	Class 15µm(EN12373-1)
Anodic film layer on date of independent inspection (microns)	16µm

None

After 11 years, no apparent signs of corrosion and no reduction in anodic film despite high density, polluted environment.

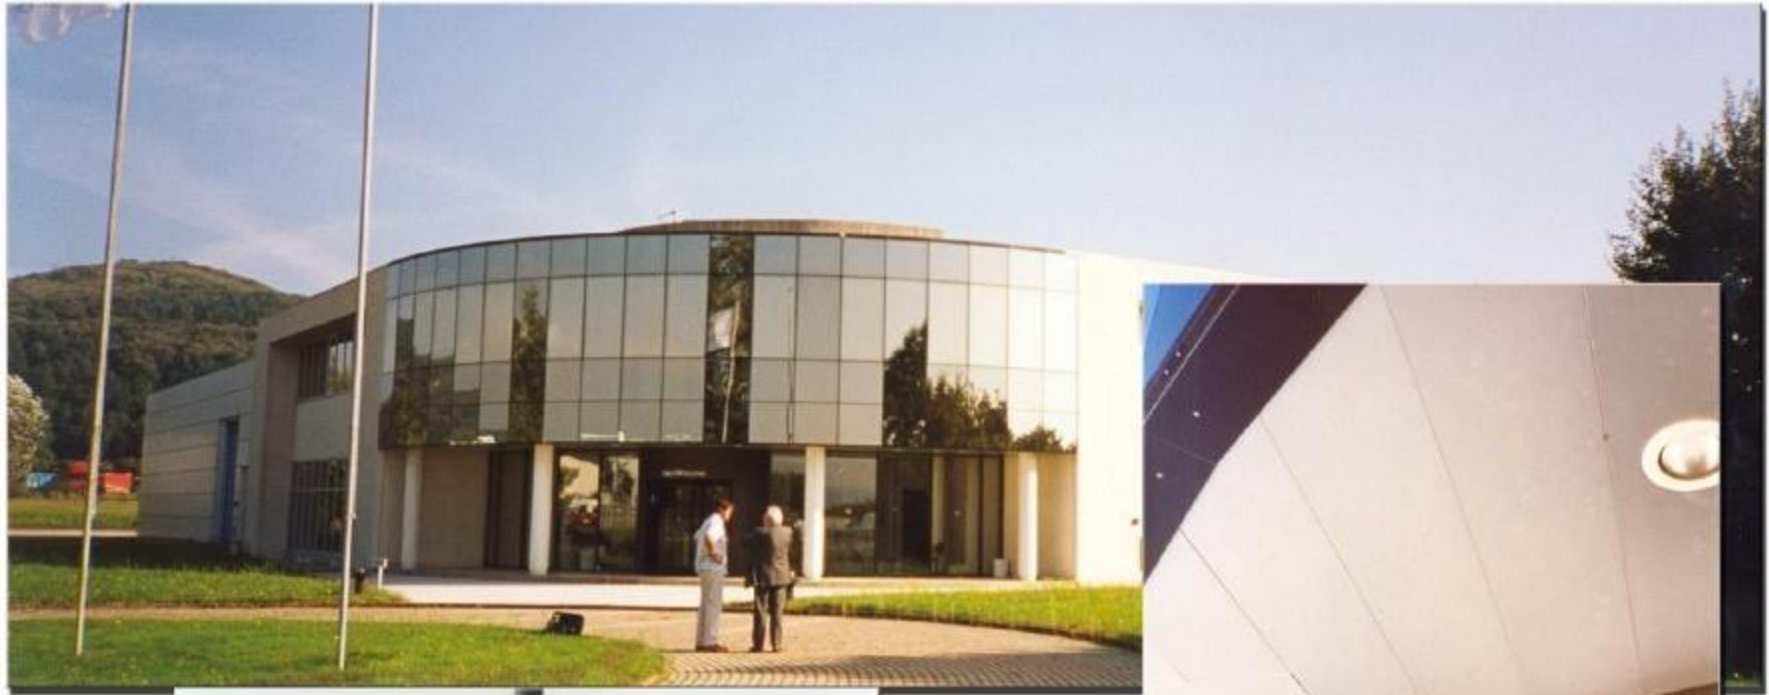
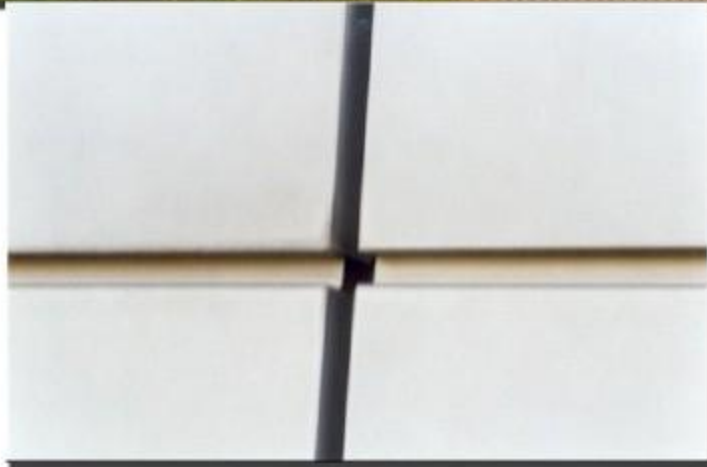
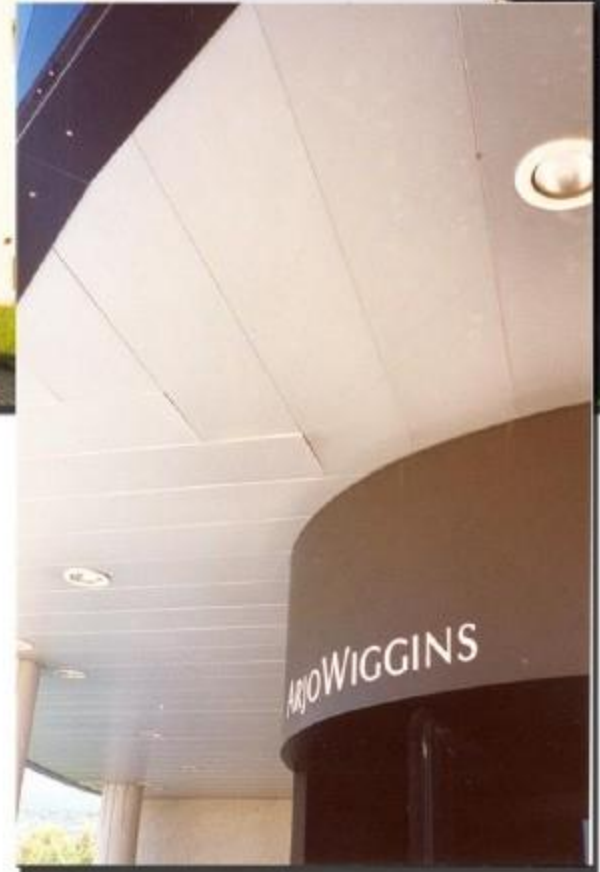
Address of building	CENTRE DE RECHERCHE ARJO-WIGGINS 40, rue du Grand Champ 38140 APPRIEU (RIVES) - FRANCE
Date of independent inspection	September 2002
Use of building	Research centre
Date of construction	1989
Environment	Rural – Small industrial zone–In proximity of a highway
Evidence of regular cleaning or maintenance	None for 13 years
External parts of building which were anodised	Panels – Cassettes - 1.5mx0.83m
Treatment	Continuous coil anodised
Anodiser	Coil N.V., Belgium
Colour	Clear
Original anodic film layer on anodised parts (microns)	Class 15µm (EN12373-1)
Anodic film layer on date of independent inspection (microns)	16µm

Visible signs of corrosion or surface degradation	None
Conclusion	After 13 years, no apparent signs of corrosion and no reduction In anodic film.

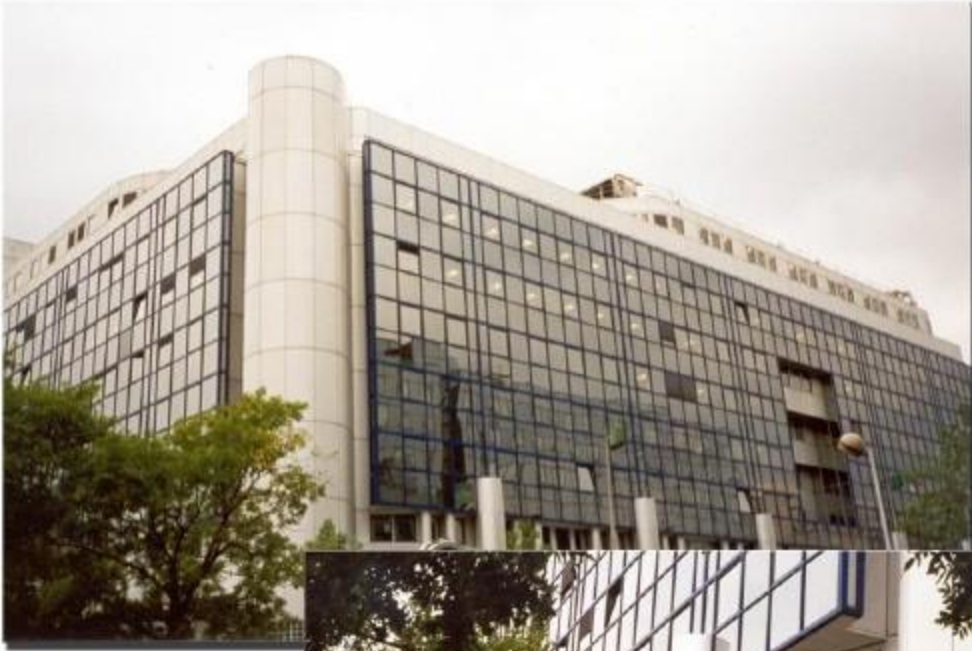
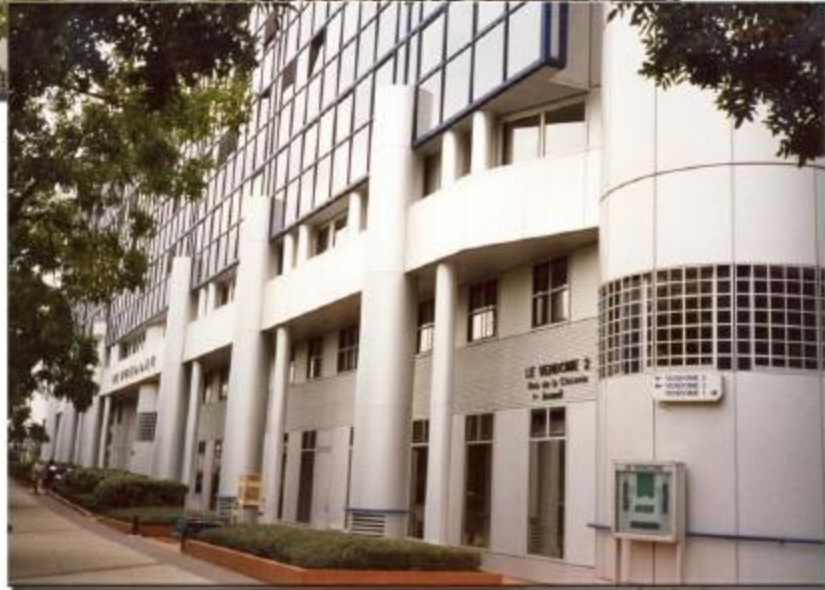
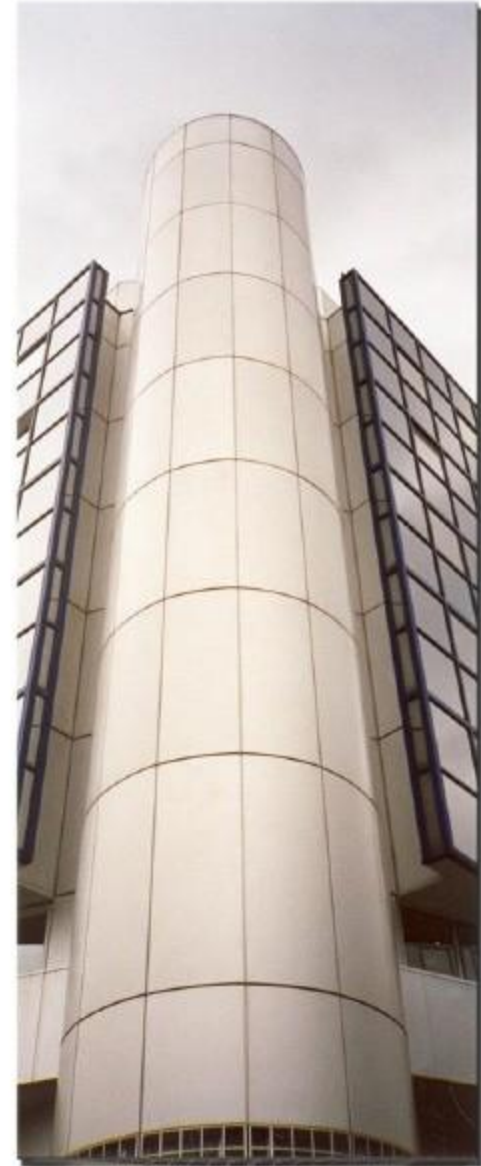
Address of building	COMPLEXE DE BUREAUX – LE VENDÔME 26, rue de la Closerie 93160 NOISY-LE-GRAND - FRANCE
Date of independent inspection	September 2002
Use of building	Offices
Date of construction	1988
Environment	Urban – High traffic density
Evidence of regular cleaning or maintenance	Yes, once a year
External parts of building which were anodised	Panels – Cassettes - 2mx1m
Treatment	Continuous coil anodised
Anodiser	Coil N.V., Belgium
Colour	Clear
Original anodic film layer on anodised parts (microns)	Class 15µm (EN12373-1)
Anodic film layer on date of independent inspection (microns)	16µm

None

After 14 years, no apparent signs of corrosion and no reduction
In anodic film despite high density, polluted environment.

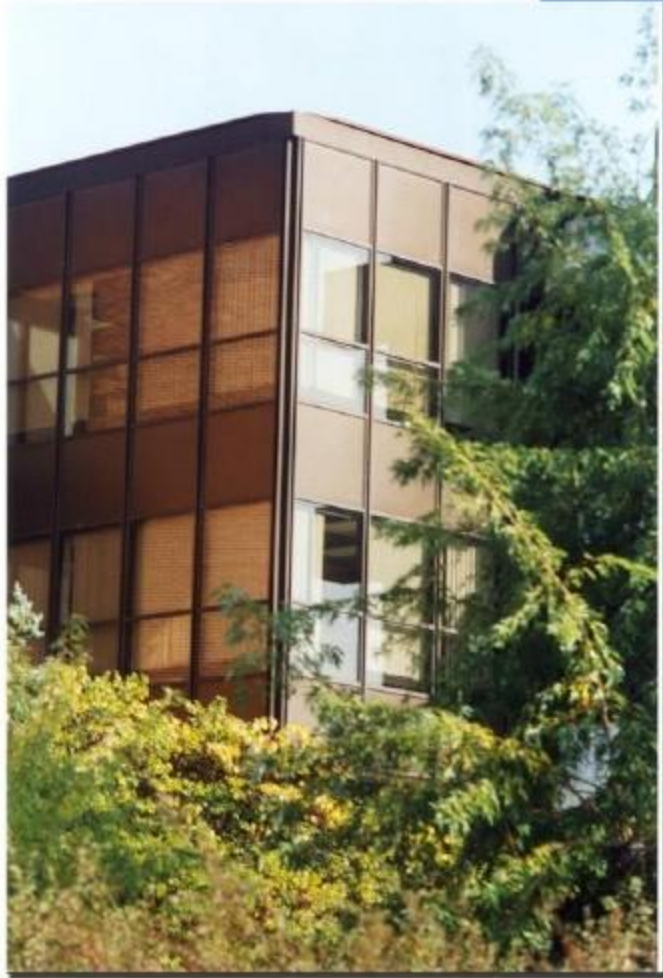
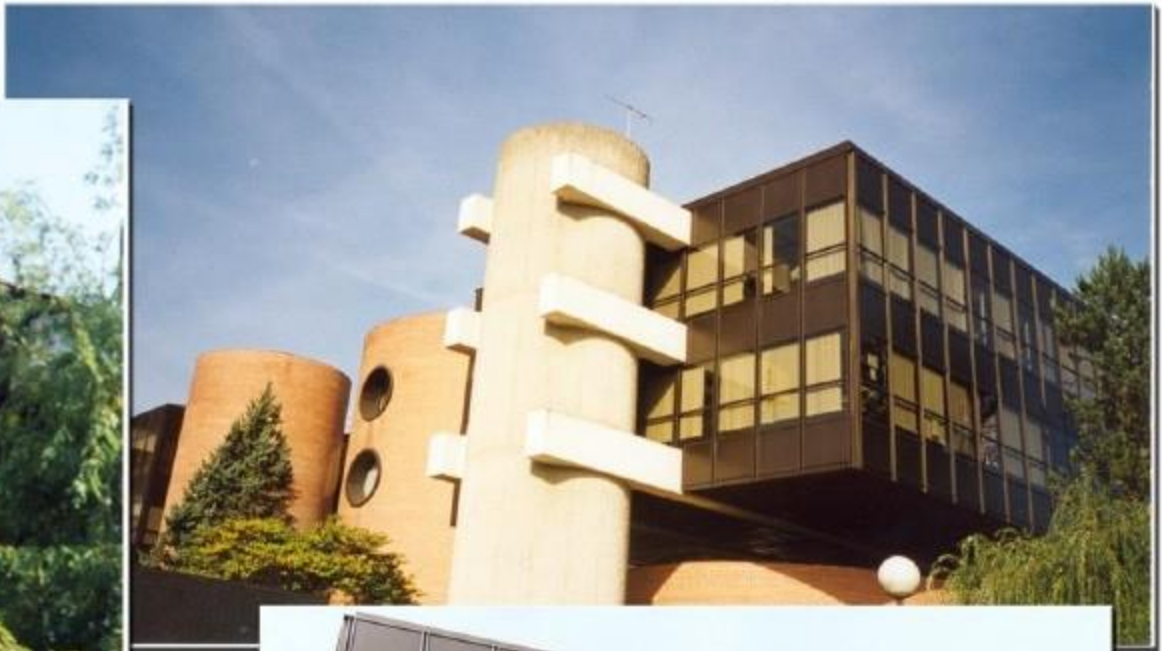
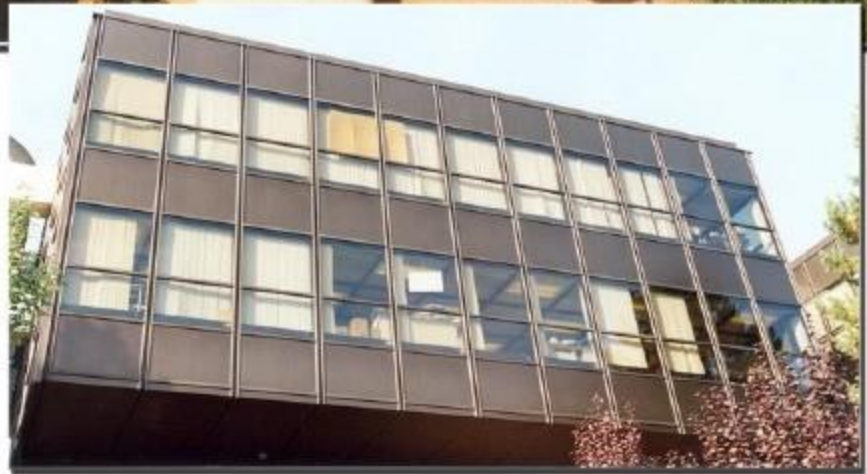
Address of building	CAISSE REGIONALE DE CREDIT AGRICOLE 26, rue de la Godde 45800 SAINT JEAN DE BRAYE - FRANCE
Date of independent inspection	September 2002
Use of building	Bank offices
Date of construction	1996 (revamping)
Environment	Rural environment
Evidence of regular cleaning or maintenance	Yes, every 2 years
External parts of building which were anodised	Sandwich panels – 1mx1m
Treatment	Continuous coil anodised
Anodiser	Coil N.V., Belgium
Colour	Clear
Original anodic film layer on anodised parts (microns)	Class 15µm (EN12373-1)
Anodic film layer on date of independent inspection (microns)	Not accessible for measurement

None

After 6 years, no apparent signs of corrosion and no reduction in anodic film.
