Independently certified audit of the long term on-site performance of continuously anodised aluminium panels on exterior architectural applications in Continental Europe

PURE ALUMINIUM

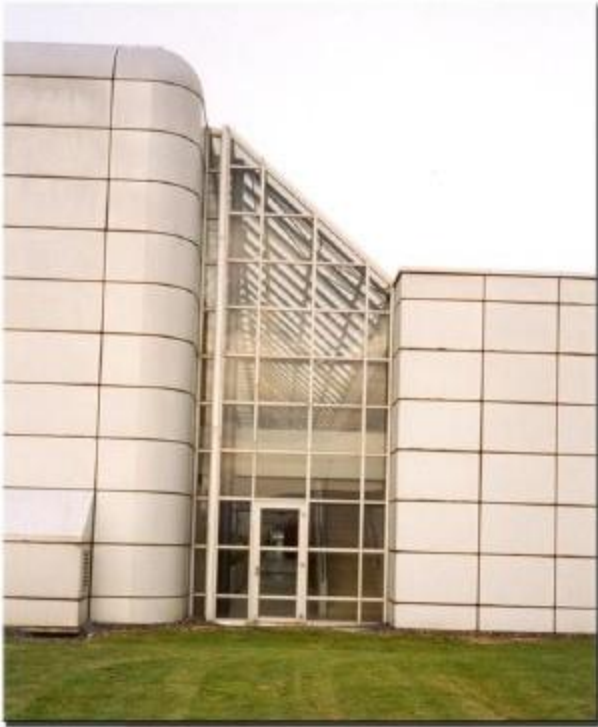
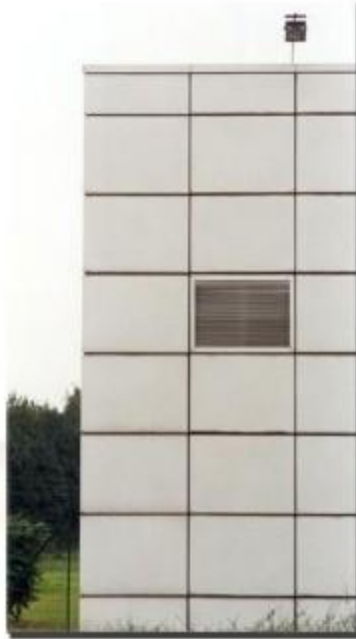
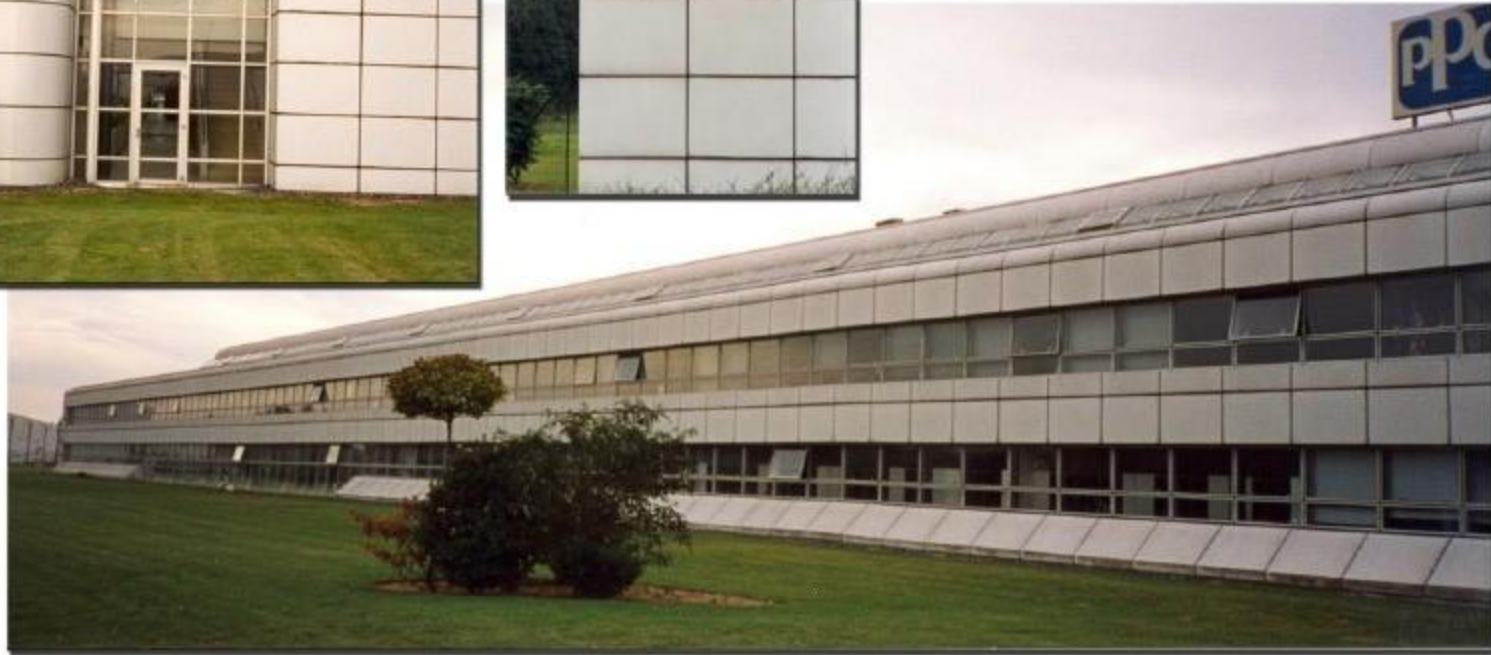
Address of building	SIEGE ADMINISTRATIF ET CENTRE DE RECHERCHE - PPG INDUSTRIES Marly 3, Z.A.E.Les Dix Muids 59583 MARLY-FRANCE
Date of independent inspection	October 2002
Use of building	Administrative offices–Research centre
Date of construction	1987
Environment	Rural – Grassland environment – Proximity of a highway
Evidence of regular cleaning or maintenance	No
External parts of building which were anodised	Panels – Cassettes
Treatment	Continuous coil anodising
Anodiser	Coil N.V., Belgium
Colour	Clear
Original anodic film layer on anodised parts (microns)	Class 15µm (EN12373-1)

Anodic film layer on date of independent inspection (microns)	16 μ m
Visible signs of corrosion or surface degradation	None
Conclusion	After 25 years, no apparent signs of corrosion and no reduction in anodic film.

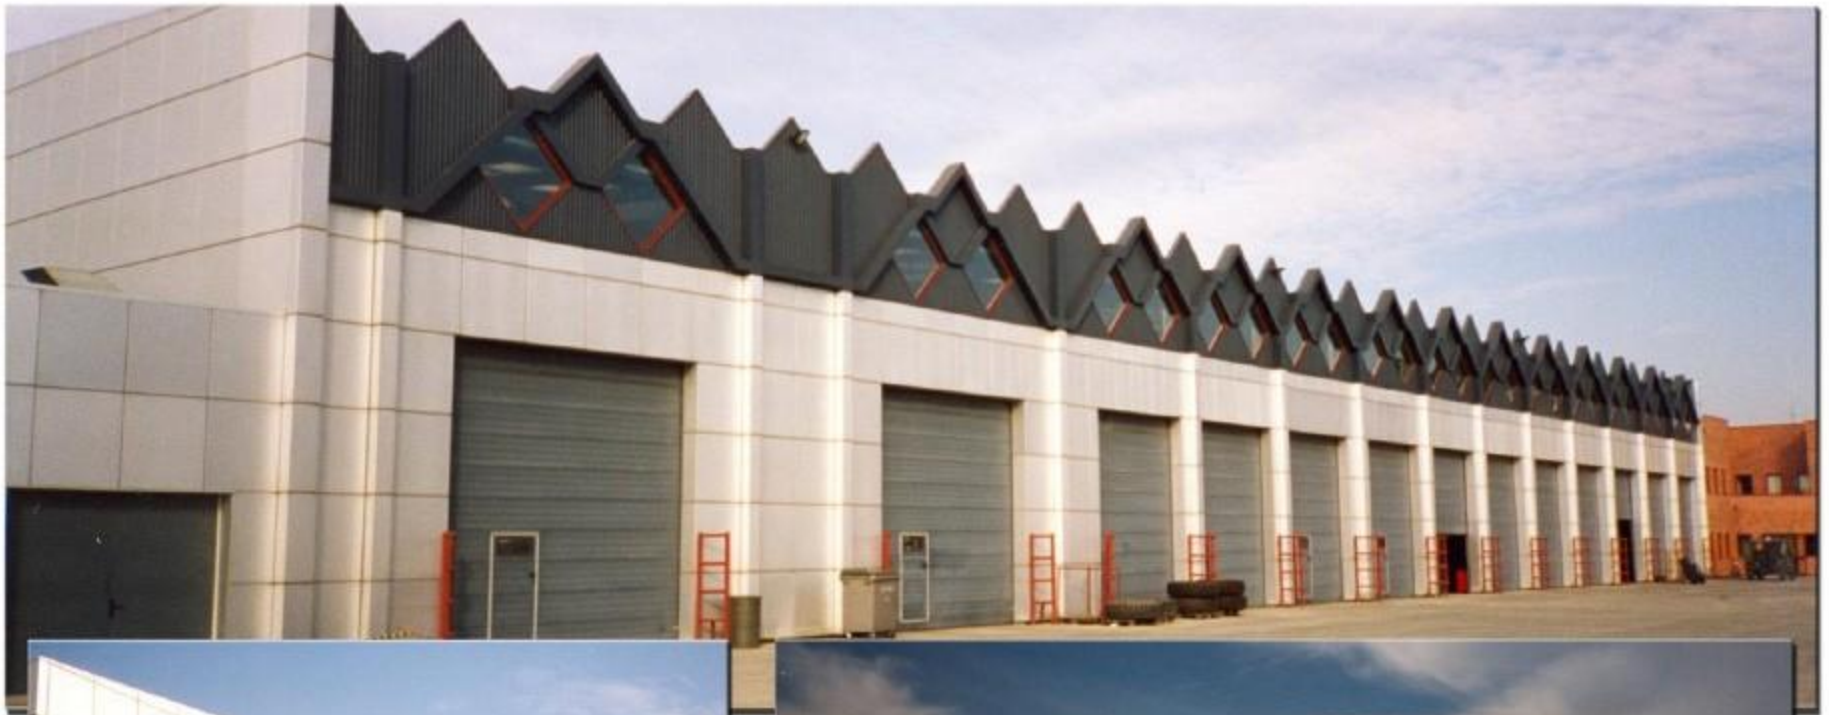
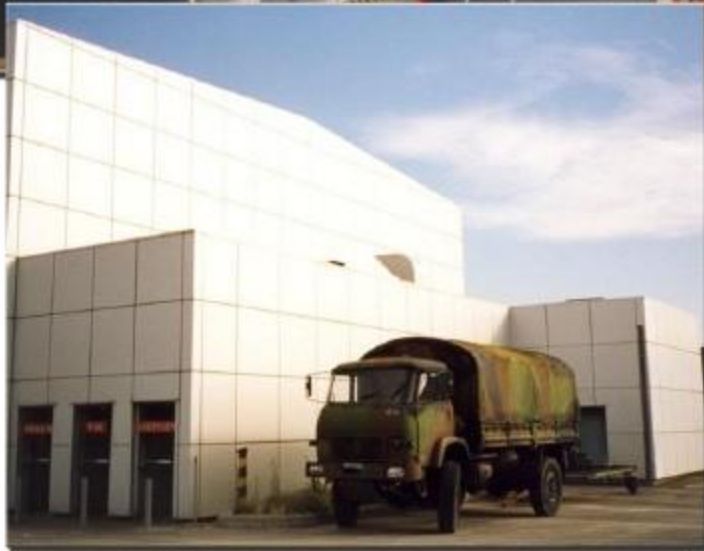
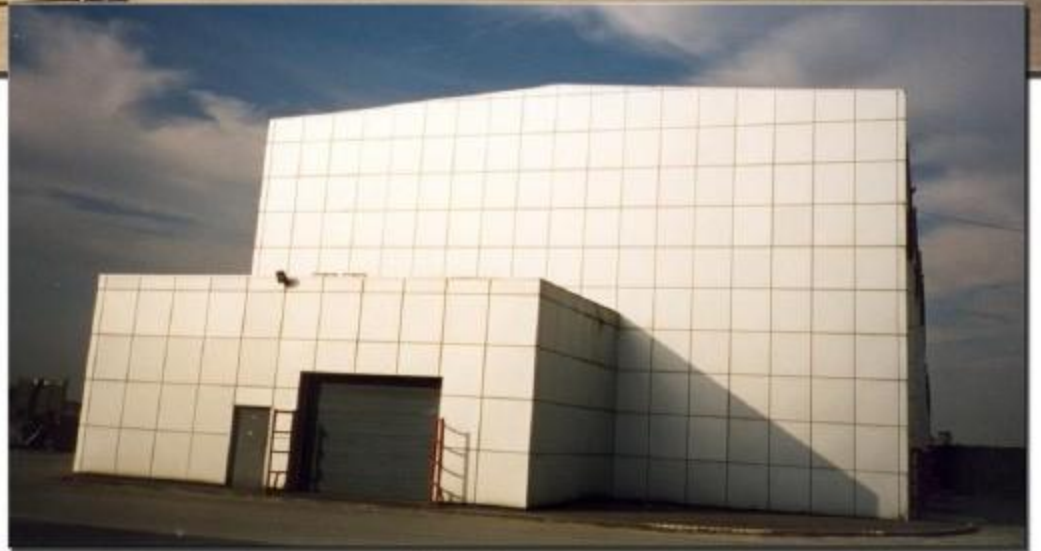
Address of building	ECOLE SUPERIEURE D'APPLICATION DU GENIE - QUARTIER BERTHEZENE rue des Petites Musses 49041 ANGERS - FRANCE
Date of independent inspection	July 2003
Use of building	Military buildings
Date of construction	1989
Environment	Rural – Suburb of Angers – Close to the Maine river
Evidence of regular cleaning or maintenance	Yes
External parts of building which were anodised	Panels – Cassettes
Treatment	Continuous coil anodised
Anodiser	Coil N.V., Belgium
Colour	Clear
Original anodic film layer on anodised parts (microns)	Class 15µm (EN12373-1)

Anodic film layer on date of independent inspection (microns)	17μm
Visible signs of corrosion or surface degradation	None
Conclusion	After 14 years, no apparent signs of corrosion and no reduction in anodic film.

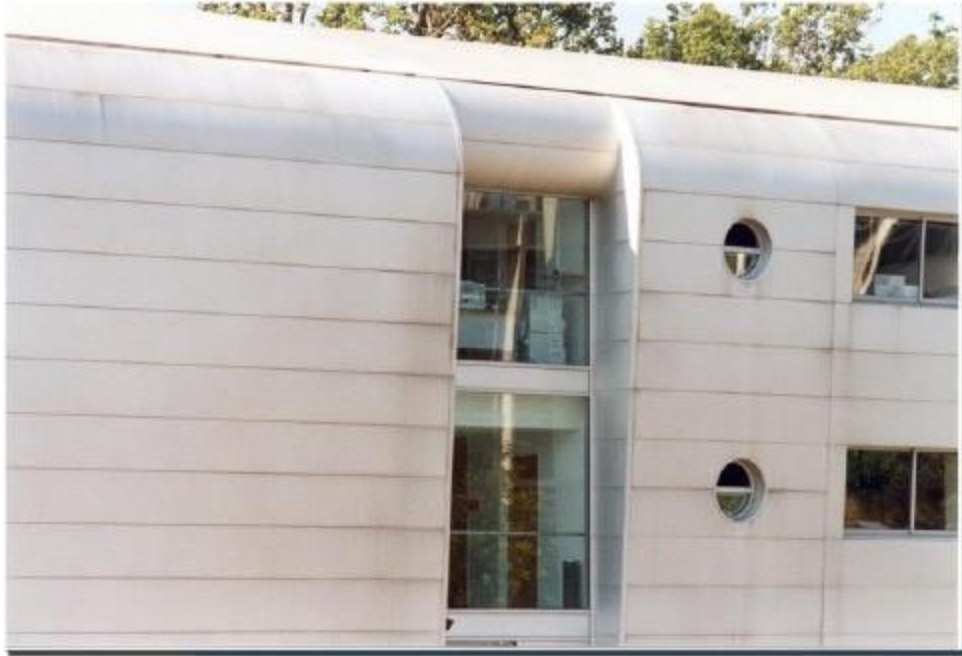
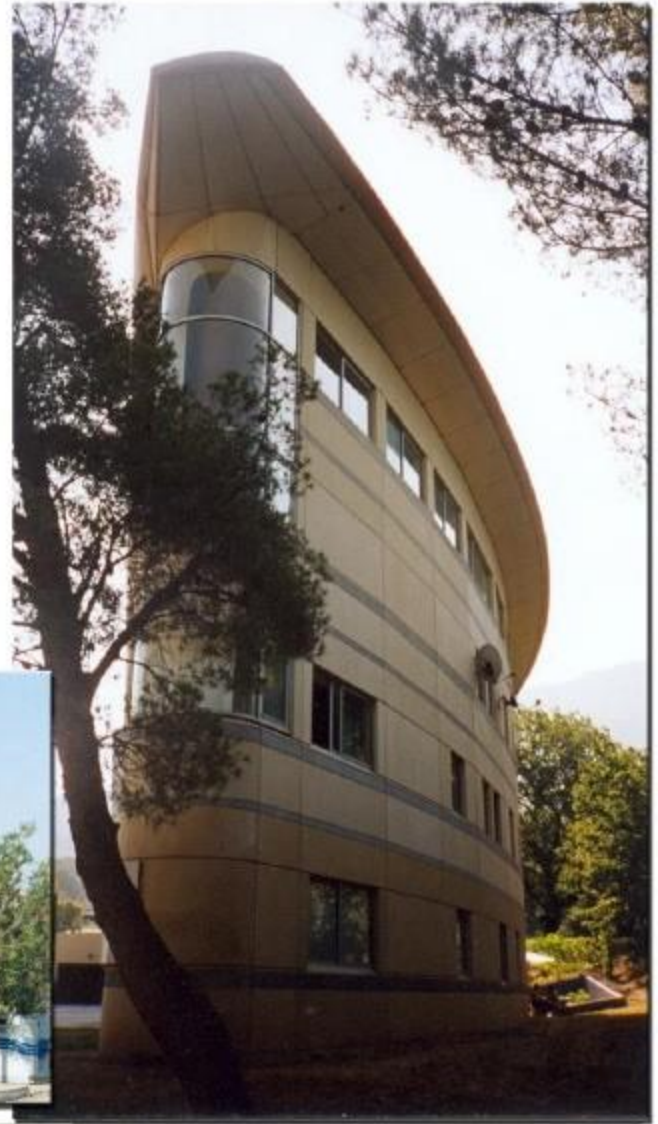
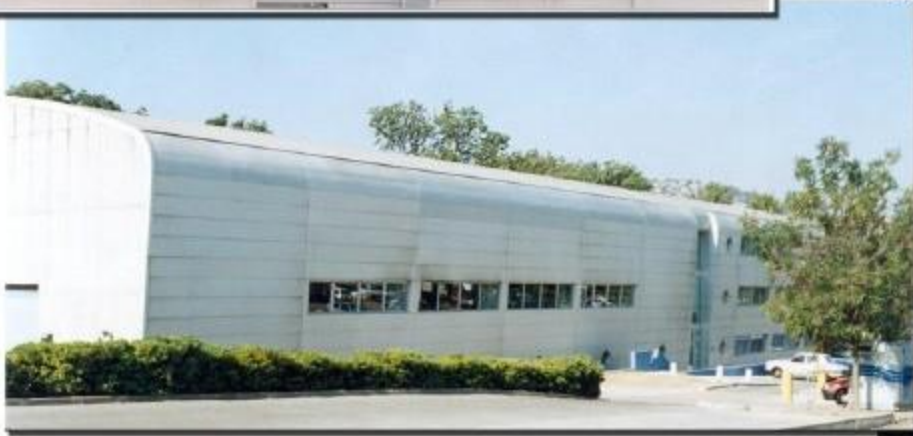
Address of building	CENTRE DE PHYSIQUE DES PARTICULES 163, avenue de Luminy 13288 MARSEILLE - FRANCE
Date of independent inspection	July 2003
Use of building	University – Research centre
Date of construction	1993
Environment	Marine–Suburb of Marseille
Evidence of regular cleaning or maintenance	No
External parts of building which were anodised	Panels – Cassettes
Treatment	Continuous coil anodised
Anodiser	Coil N.V., Belgium
Colour	Clear
Original anodic film layer on anodised parts (microns)	Class 15µm (EN12373-1)
Anodic film layer on date of independent inspection (microns)	16µm

Visible signs of corrosion or surface degradation	None
Conclusion	After 10 years, no apparent signs of corrosion and no reduction in anodic film.

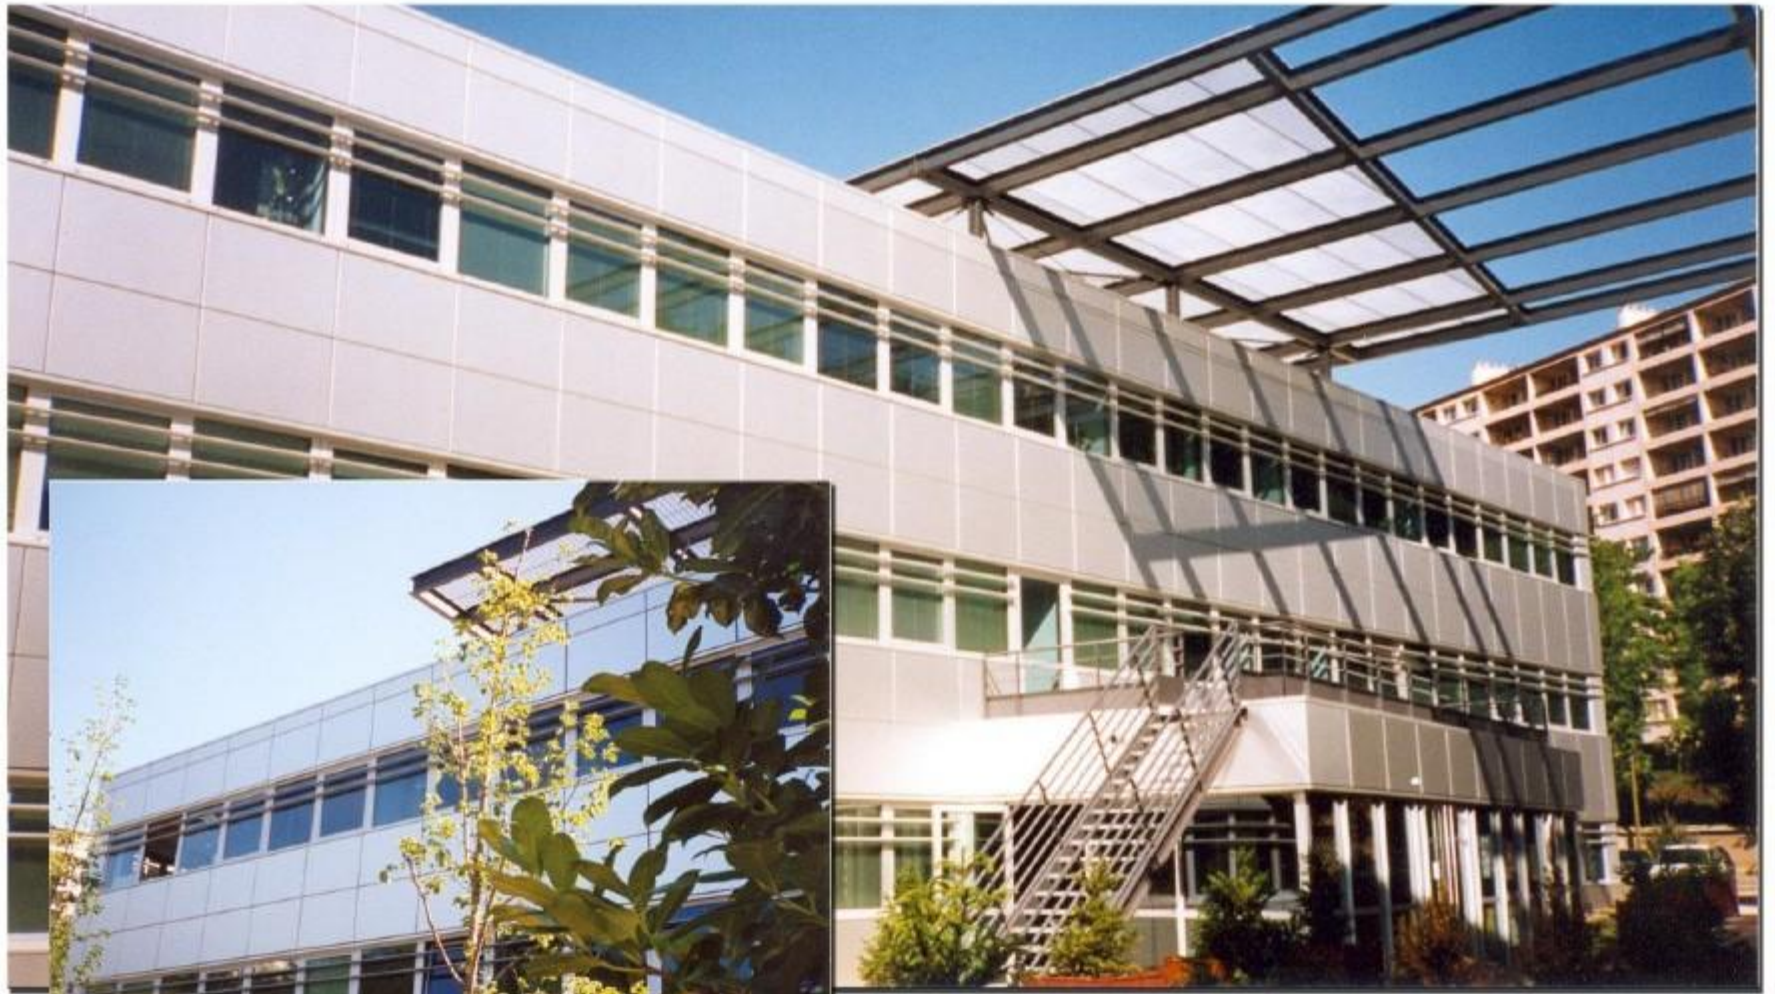
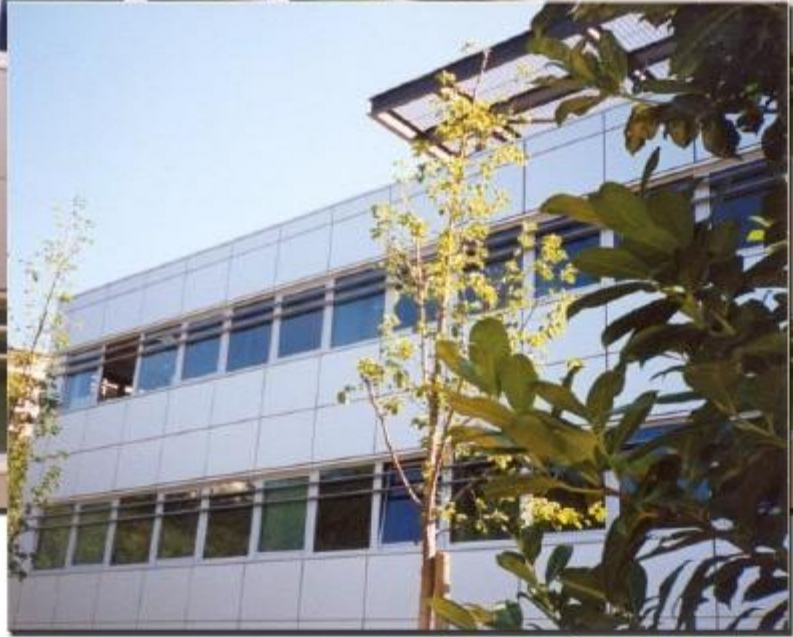
Address of building	CONSEIL ECONOMIQUE ET SOCIAL REGIONAL REGION RHONE-ALPES SITE VALD'ECULLY 4, chemin du Ruisseau 69130 ECULLY-FRANCE
Date of independent inspection	July 2003
Use of building	Regional government offices
Date of construction	2001
Environment	Urban – Suburb of Lyon – Highway cross sections–High traffic density
Evidence of regular cleaning or maintenance	No
External parts of building which were anodised	Panels – Cassettes - 1.5mx0.83m
Treatment	Continuous coil anodised
Anodiser	Coil N.V., Belgium
Colour	Clear
Original anodic film layer on anodised parts (microns)	Class 15µm (EN12373-1)
Anodic film layer on date of independent inspection (microns)	16µm

None

After 2 years, no apparent signs of corrosion and no reduction in anodic film despite high density, polluted environment.

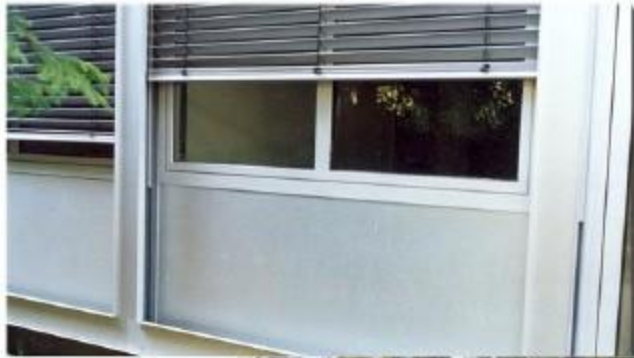
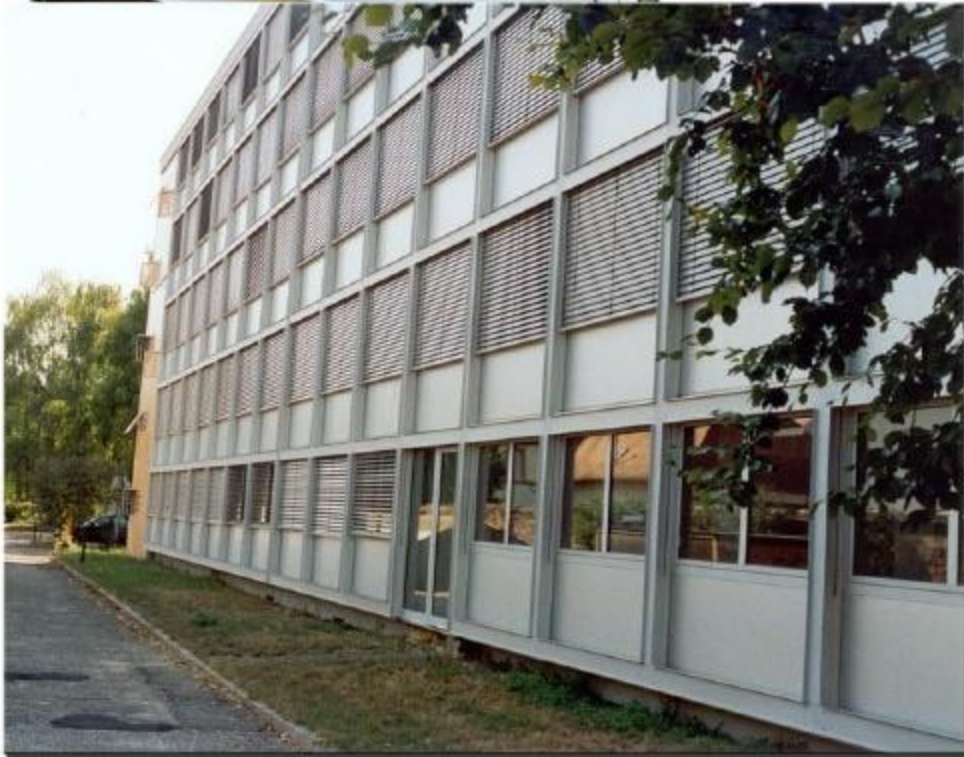
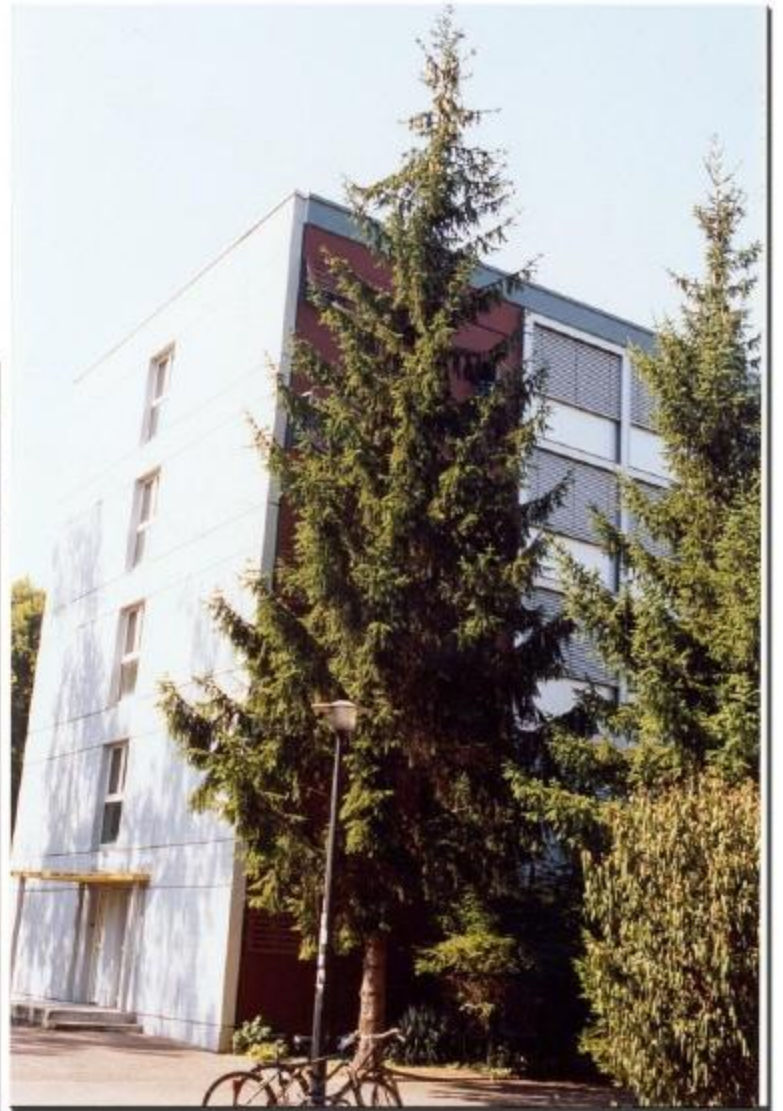
Address of building	CITE UNIVERSITAIRE DE LA ROBERTSAU 14, route de la Wantzenau 67085 STRASBOURG-FRANCE
Date of independent inspection	August 2003
Use of building	University lodgings
Date of construction	1998 (revamping)
Environment	Semi-rural – Suburb of Strasbourg
Evidence of regular cleaning or maintenance	No
External parts of building which were anodised	Solid panels
Treatment	Continuous coil anodised
Anodiser	Coil N.V., Belgium
Colour	Clear
Original anodic film layer on anodised parts (microns)	Class 15 μ m (EN12373-1)
Anodic film layer on date of independent inspection (microns)	16 μ m

Visible signs of corrosion or surface degradation	None
Conclusion	After 5 years, no apparent signs of corrosion and no reduction in anodic film.

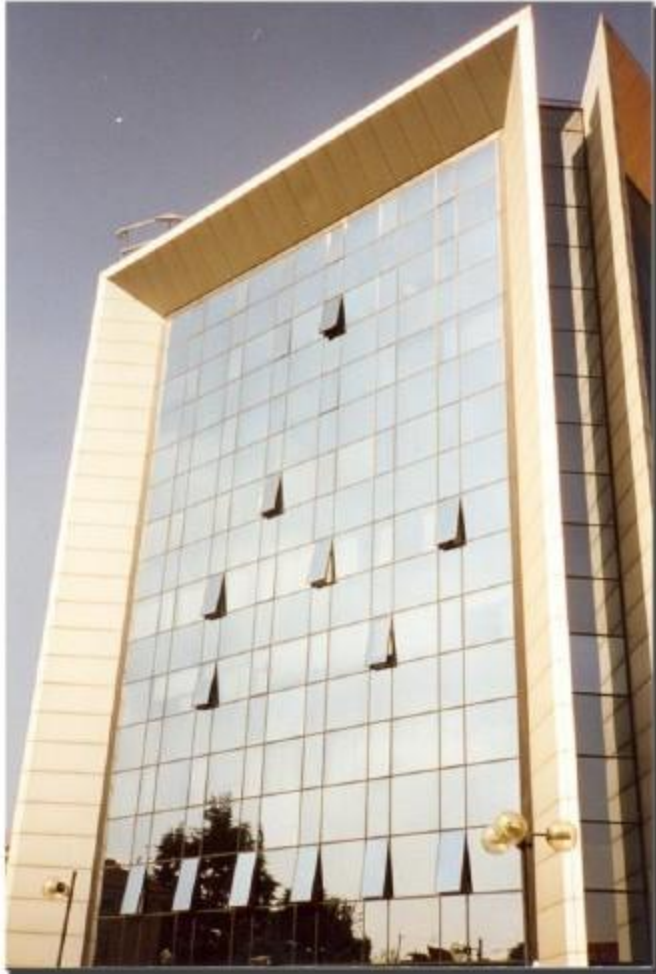
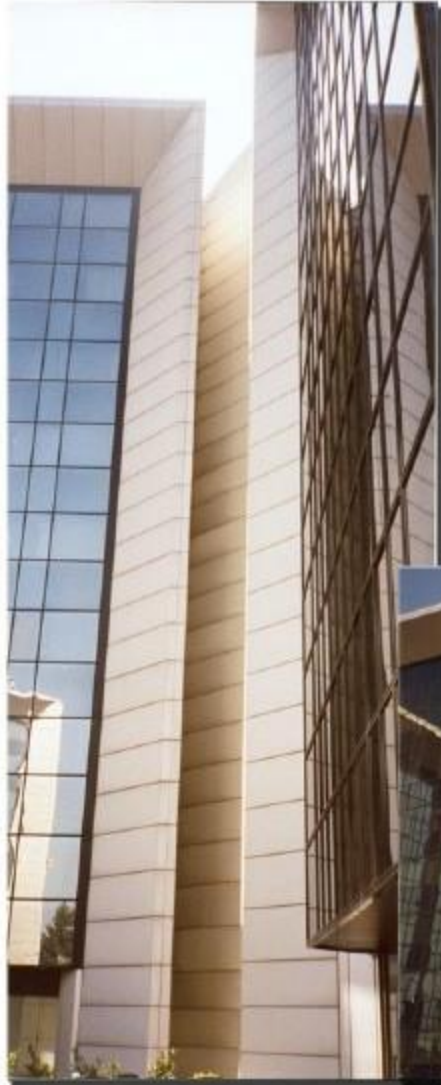
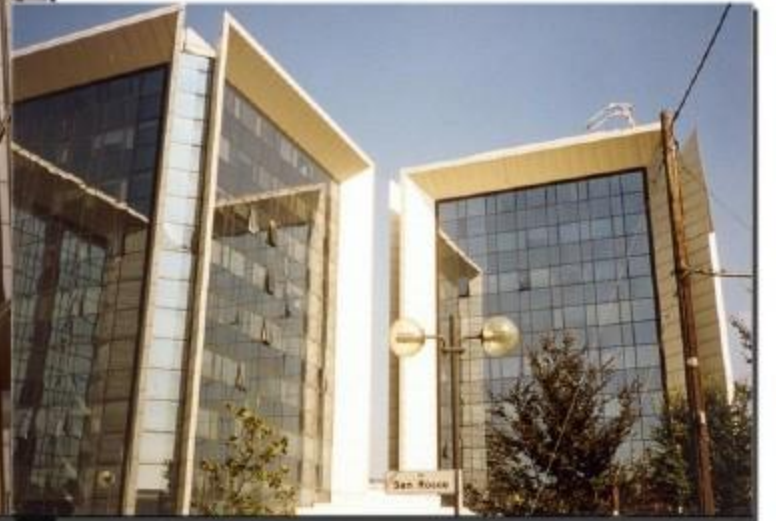
Address of building	PÔLE TERTIAIRE DE GALLARATE-LETORRI Via Marsala 21013 GALLARATE-ITALY
Date of independent inspection	September 2003
Use of building	Offices
Date of construction	1990
Environment	Semi-urban – 30km from Milan–Close to Malpensa Airport
Evidence of regular cleaning or maintenance	No
External parts of building which were anodised	Panels – Cassettes - 2.5mx0.8m
Treatment	Continuous coil anodised
Anodiser	Coil N.V., Belgium
Colour	Clear
Original anodic film layer on anodised parts (microns)	Class 12µm (EN12373-1)
Anodic film layer on date of independent inspection (microns)	14µm

None

After 13 years, no apparent signs of corrosion and no reduction
In anodic film.
